**Flood Control Project Maintenance
Levee Inspections**
LMA District Cover Sheet
Spring 2016 Levee Inspection Results

Reclamation District No. 0017 Mossdale

Spring 2016 Levee Inspection Results

Waterway			Bank	Unit Miles
Unit No. 01 French Camp Slough			Left	1.76
	Spring (March - May)	Summer (June - August)	(September - November) Fall	Winter (December - February)
Unit Maintenance Rating (Fall Only)				
Date of Inspection	4/5/2016 - 4/5/2016			
DWR Inspector	Richard Willoughby			
Accompanied By	Robert Winter KSN

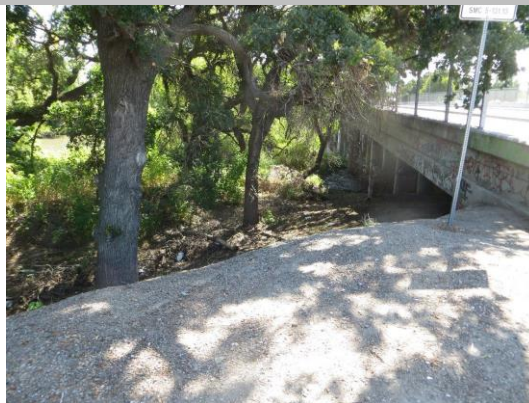
Photo 2 of 2 : UCIP_SP_2016_46010_74221.jpg

FS_ID:46010
DS_ID:72
EP_NO: 15185
Repair Type: Urgent
Crossing Status: Indicator Found
UCIP Comments: Need to install gasoline markers.
FIELD_STRUCT_DESC: 8-inch-diameter soil proofed steel gas main through the left bank levee and under the channel of French Camp Slough. The pipeline has a minimum cover of 5 feet within the overflow areas and under the channel. (Permit No. 15185-1989)
FS Date: 5/19/2015

WS Slope. No gasoline markers.

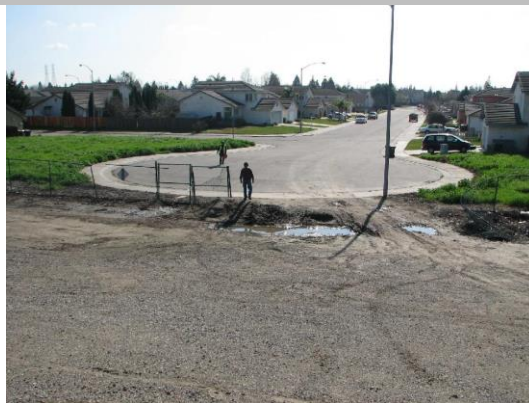
Photo 2 of 2 : UCIP_SP_2016_40604_38489.jpg

FS_ID:40604
DS_ID:2
EP_NO: 14992
Repair Type: Non-Urgent
Crossing Status: Indicator Found
UCIP Comments: Need to contact owner to determine status of crossing. Also need date of last inspection.
FIELD_STRUCT_DESC: 1 of 3. 30-inch diameter HDPE sewer force main (SFM). All pipes encased in concrete at approximately 32 feet below levee crown. (Permit No. 14992-1989)
FS Date: 2/3/2010

View of landward side.

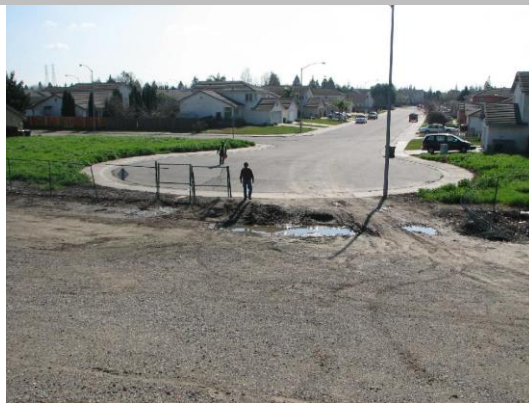
Photo 2 of 2 : UCIP_SP_2016_40605_38503.jpg

FS_ID:40605
DS_ID:159
EP_NO: 14992
Repair Type: Non-Urgent
Crossing Status: Indicator Found
UCIP Comments: Need to contact owner to determine status of crossing. Also need date of last inspection.
FIELD_STRUCT_DESC: 2 of 3. A 30-inch diameter HDPE sewer force main (SFM). All pipes encased in concrete at approximately 32 feet below levee crown. (Permit No. 14992-1989)
FS Date: 2/3/2010

View of landward toe--established neighborhood.

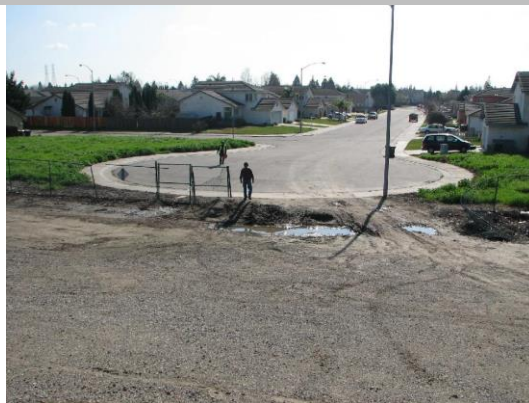
Photo 2 of 2 : UCIP_SP_2016_40606_71941.jpg

FS_ID:40606
DS_ID:158
EP_NO: 14992
Repair Type: Non-Urgent
Crossing Status: Indicator Found
UCIP Comments: Need to contact owner to determine status of crossing. Also need date of last inspection.
FIELD_STRUCT_DESC: 3 of 3. A 12-inch diameter HDPE sewer force main (SFM). All pipes encased in concrete at approximately 32 feet below levee crown. (Permit No. 14992-1989)
FS Date: 2/3/2010

View of landward side.

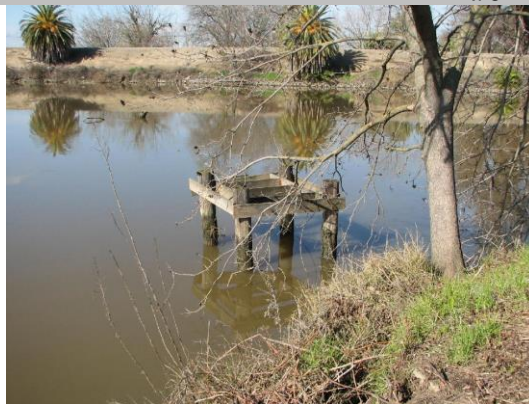
Photo 2 of 2 : UCIP_SP_2016_40628_38515.jpg

FS_ID:40628
DS_ID:75
EP_NO: 15093
Repair Type: Non-Urgent
Crossing Status: Found
UCIP Comments: Only appurtenances remaining at this location--4 pillings located on waterward side. According to records the pillings were to be removed under a completion maintenance contract. Need to coordinate with owner.
FIELD_STRUCT_DESC: 14-inch-diameter pipeline through levee at unknown depth. Per inspector's notes "this crossing is abandoned almost all materials removed including pipes, conduit, and pumphouse. The only items left are 4 pilings which are to be removed under a completion maintenance contract. Approximately 200 feet of reinforced concrete pipe lateral removed in R/W south of crossing".
FS Date: 2/3/2010

View of waterward side--pillings inside channel.

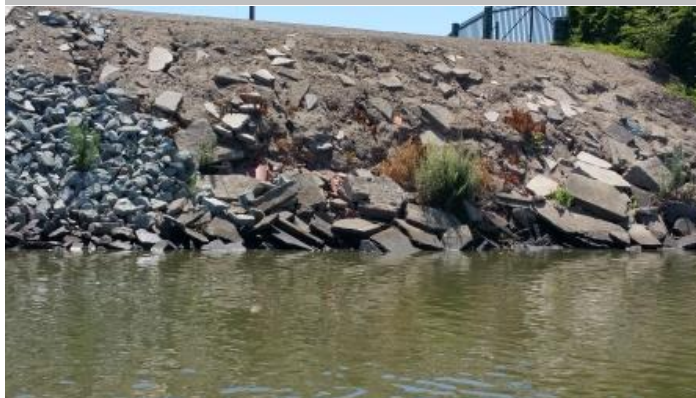
Photo 2 of 2 : SP_2016_RD0017_304_2_20160404_00005.jpg

LM Start	1.08	Rating **	U	Issue No.	2
LM End	1.08	Issue Type +	Ma	Location *	WS
Category	Supplemental			GPS Latitude/Longitude	
				Start	End
Item	DWR Erosion Survey			37.902530 °	37.902530 °
				-121.325690 °	-121.325690 °
DWR ID	DWR_RD0017_02_s_2016_2				
Comment Code					
Inspector Comment					
06/24/2015: No significant change observed. 6/19/2014: No significant change observed. 08/13/2013: No significant change at this site. 08/07/2012: The erosion is nearly vertical, and has developed upward to halfway of the levee slope. The protecting concrete blocks have been washed away. Animal activities are visible. [2015 Site ID:RD0017U02RM44.32]

Close view of the erosion.

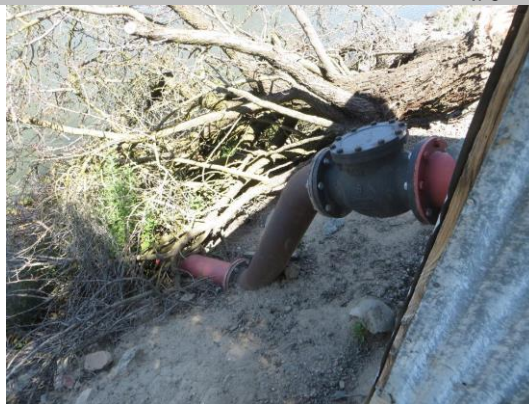
Photo 2 of 2 : UCIP_SP_2016_45959_74427.jpg

Comment Code					
Inspector Comment					
FS_ID:45959 DS_ID:8 EP_NO: 15097 Repair Type: Urgent Crossing Status: Found UCIP Comments: 05/19/15 Hole located on landward toe is still present and covered by dense vegetation. Hole is approximately 6 feet in diameter. 02/10/10 Exposed section of levee on landward side--sink hole located at landward toe. Need to contact owner and DWR inspector to address issue. FIELD_STRUCT_DESC: 8-inch diameter irrigation pipeline through levee. Invert of pipe is 4.0 feet below levee crown. Pump house is located on the waterward slope. Siphon breaker on landward shoulder, standpipe located 10 feet from landward tee. Concrete stairs on waterward slope. (Permit No. 15097-1990) FS Date: 5/19/2015

(2015) Pipe visible on waterward side.

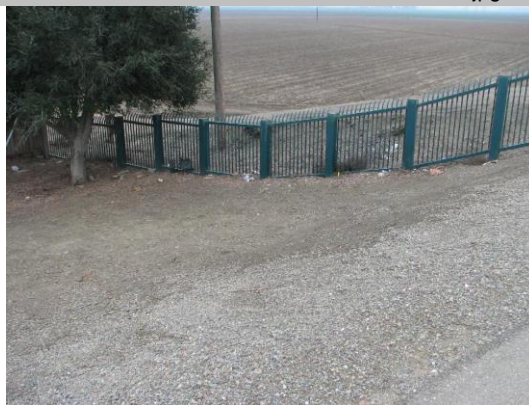
Photo 2 of 2 : UCIP_SP_2016_40639_38686.jpg

LM Start	1.45	Rating **	M	Issue No.	601
LM End	1.45	Issue Type +	En	Location *	WS
Category	Supplemental			GPS Latitude/Longitude	
				Start	End
Item	DWR UCIP Field Study			37.897280 °	37.897280 °
				-121.326775 °	-121.326775 °
DWR ID					
Comment Code					
Inspector Comment					
FS_ID:40639					
DS_ID:11					
EP_NO: 15316					
Repair Type: Non-Urgent					
Crossing Status: Indicator Found					
UCIP Comments: Need to contact owner to determine status--pipe was not found only siphon breaker housing unit.					
FIELD_STRUCT_DESC: 8 inch diameter discharge pipeline through levee. Invert of pipe is 3.8 feet below levee crown. Siphon breaker on the waterward shoulder. Pump is located inside ditch located approximately 75 feet landward of levee toe. (Permit No. 15316-1989)					
FS Date: 2/4/2010

View of landward side.

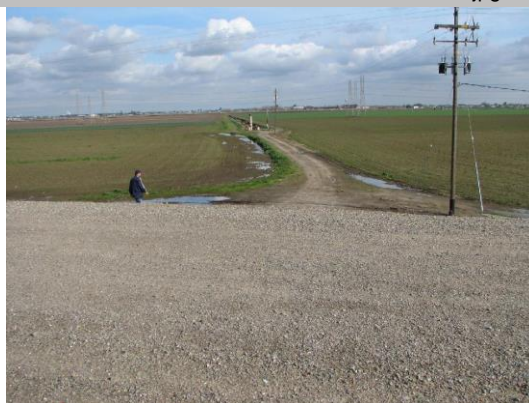
Photo 2 of 2 : UCIP_SP_2016_40642_38740.jpg

Comment Code					
Inspector Comment					
FS_ID:40642					
DS_ID:14					
EP_NO: 15317					
Repair Type: Non-Urgent					
Crossing Status: Found					
UCIP Comments: Need to coordinate with owner to determine status of crossing. Need to find out if pipe located on landward side is tied to pipe through levee. Pipe found on waterward side is filled with concrete (non-functional).					
FIELD_STRUCT_DESC: 10 inch diameter steel stormwater discharge pipeline through levee. Invert of pipe is 4.74 feet below levee crown. Siphon breaker on waterward slope. Pump in ditch located 300 feet landward of toe. Ramp on landward slope. 10 inch pipe connects to an existing 16 inch discharge pipe on the landward side. (Permit No. 15317-1990) This pipe was installed during the levee work approved under encroachment number 15014.					
FS Date: 2/4/2010

View of landward side.

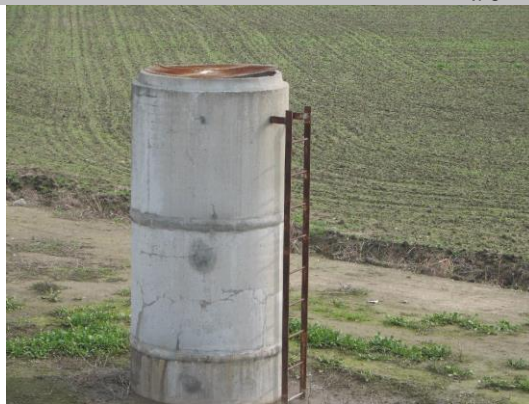
Photo 2 of 2 : UCIP_SP_2016_40645_72001.jpg

Comment Code					
Inspector Comment					
FS_ID:40645					
DS_ID:16					
EP_NO: 15102					
Repair Type: Non-Urgent					
Crossing Status: Found					
UCIP Comments: Need to coordinate with owner to determine status of crossing.					
FIELD_STRUCT_DESC: 20 inch diameter irrigation pipeline through levee. Invert of pipe is 2.8 feet below levee crown. Fill placed over the pipeline to provide 2.0 feet of cover. Siphon breaker on waterward shoulder. Pump on platform with walkway to shoulder, standpipe located 15 feet landward tee, concrete stairway en waterward slope. (Permit No. 15102-1990) This pipe was installed during the levee work approved under encroachment number 15014.					
FS Date: 2/4/2010

Standpipe located on landward toe.

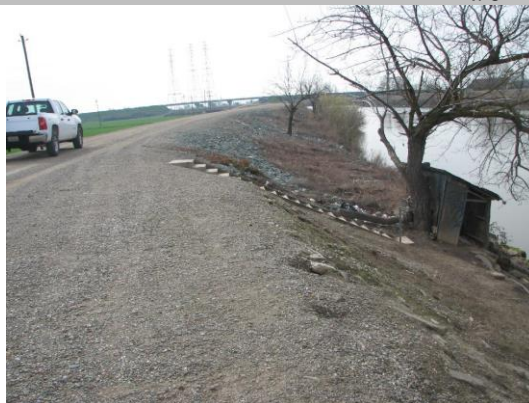
Photo 1 of 2 : UCIP_SP_2016_40646_72010.jpg

Comment Code					
Inspector Comment					
FS_ID:40646					
DS_ID:17					
EP_NO: 15103					
Repair Type: Non-Urgent					
Crossing Status: Found					
UCIP Comments: Need to coordinate with owner to determine status of crossing. If crossing is no longer in use owner will need to contact the CVFPB to comply with Title 23.					
FIELD_STRUCT_DESC: 8 inch diameter steel irrigation pipeline through levee. Invert of pipe is 3.47 feet below crown. Siphon breaker on landward shoulder. Pump house on waterward slope, standpipe located 10 feet from landward tee. Concrete stairway on waterward slope. (Permit No. 15103-1990) This pipe was installed during the levee work approved under encroachment number 15014.					
FS Date: 2/4/2010

View of waterward side.

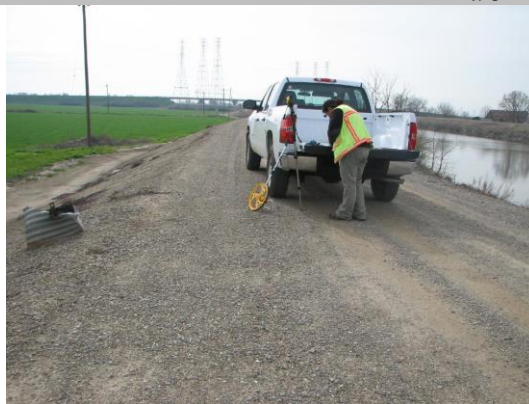
Photo 2 of 2 : UCIP_SP_2016_40646_72009.jpg

View of levee crown at crossing.

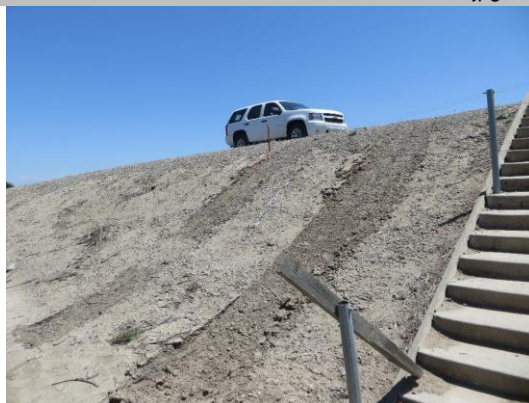
Photo 2 of 2 : UCIP_SP_2016_46009_74441.jpg

(2015) View of waterward slope--pipe removed.

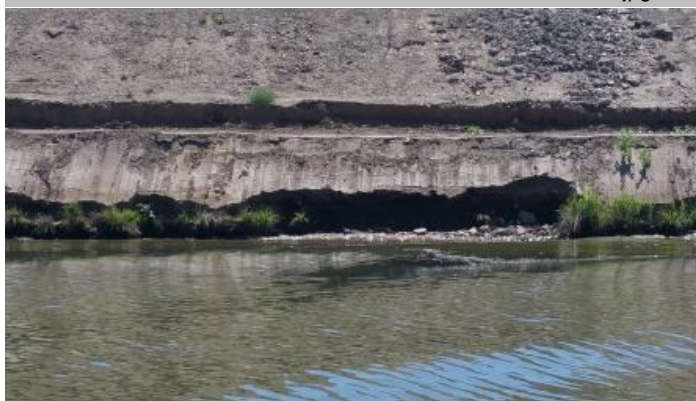
Photo 2 of 2 : SP_2016_RD0017_304_6_20160404_00007.jpg

Close view of the erosion.

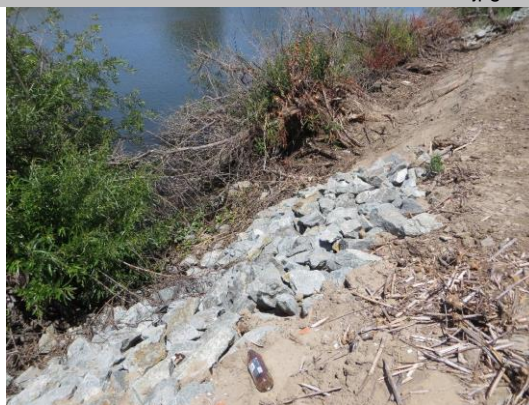
Photo 2 of 2 : UCIP_SP_2016_46004_74454.jpg

(2015) Waterward slope armored with rip rap.

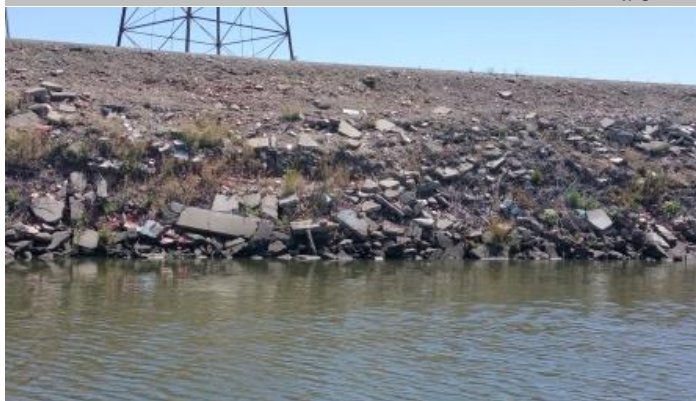
Photo 2 of 2 : SP_2016_RD0017_304_8_20160404_00009.jpg

Close view of the erosion. The slope protection is poor.

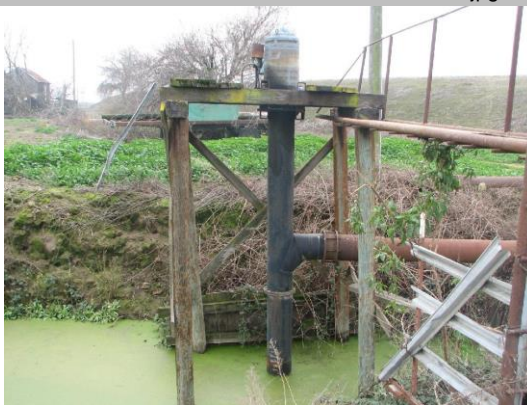
Photo 2 of 2 : UCIP_SP_2016_40659_72115.jpg

Pump station locate on landward side.

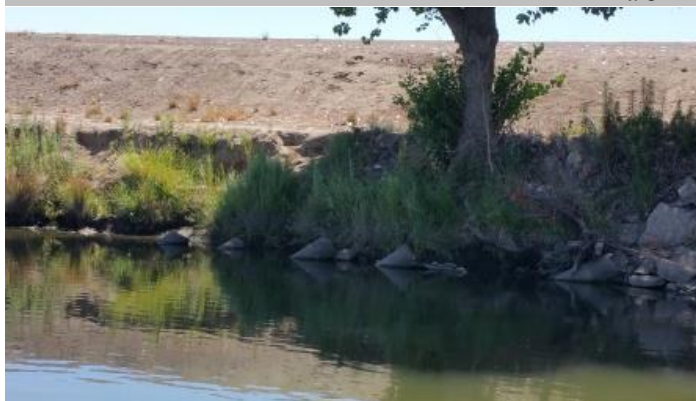
Photo 2 of 2 : SP_2016_RD0017_304_10_20160404_00012.jpg

Close view of the erosion.

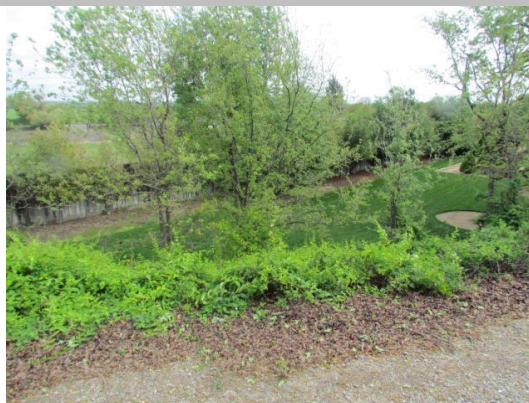
Photo 3 of 3 : SP_2016_RD0017_304_48_20160404_00016.jpg

Looking east at overgrown landscaping on landside slope. (Spring 2014)

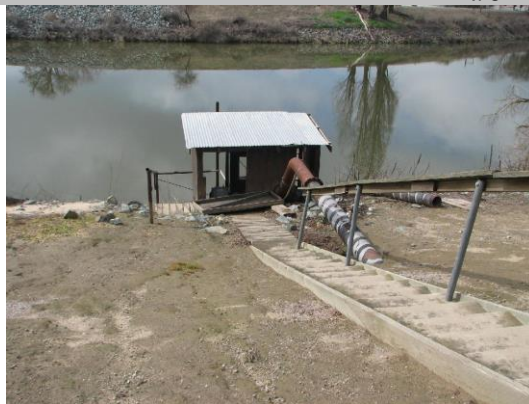
Photo 2 of 2 : UCIP_SP_2016_40662_72128.jpg

View of waterward side--pump house, walkway, pipe, and abandone pipe section.

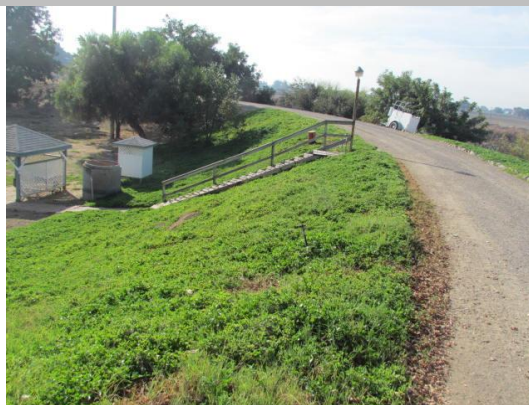
Photo 1 of 3 : SP_2016_RD0017_304_1_20160404_00001.jpg

Looking southeast at ground cover on landside slope.

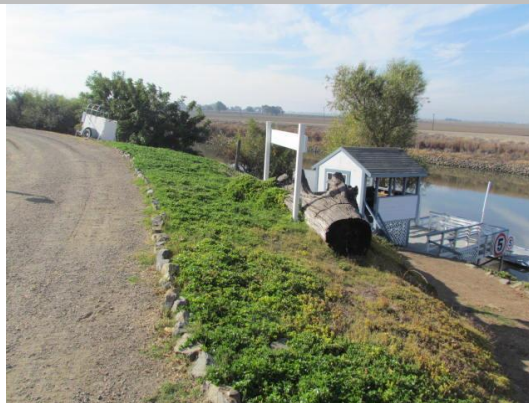
Photo 3 of 3 : SP_2016_RD0017_304_1_20160404_00003.jpg

Looking southwest at landscaping and boat dock on waterside slope and channel.

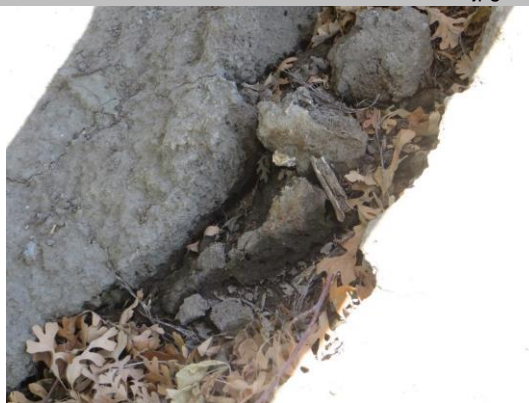
Photo 2 of 2 : UCIP_SP_2016_45998_74485.jpg

(2015) Wet ground along pipe alignment on waterward side.

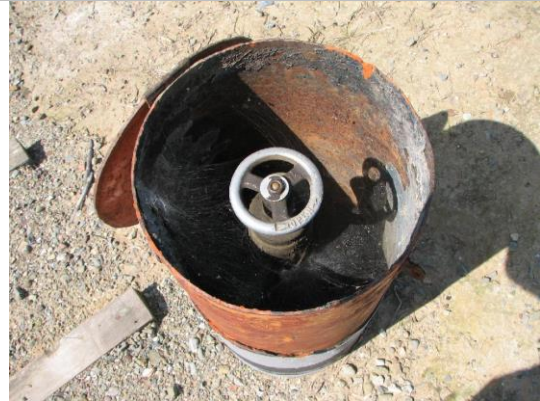
Photo 2 of 2 : UCIP_SP_2016_40677_72294.jpg

Siphon breaker located on waterward side.

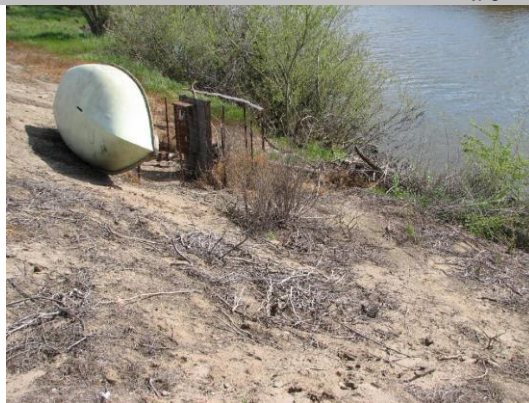
Photo 2 of 2 : UCIP_SP_2016_40680_72313.jpg

Abandoned boat protecting pump station located on waterward side.

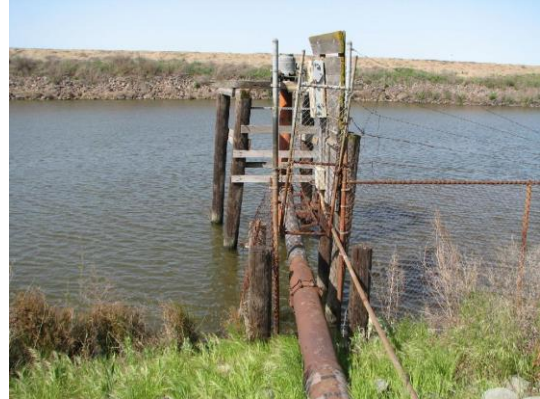
Photo 2 of 2 : UCIP_SP_2016_40681_72328.jpg

Pipe, pump, and platform located on waterward side.

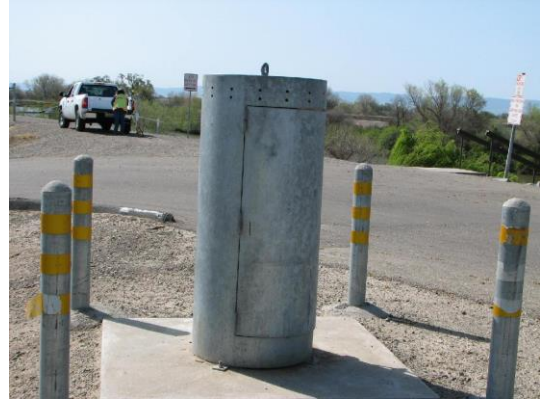
Photo 2 of 2 : UCIP_SP_2016_40682_72321.jpg

Relief valve located on landward shoulder.

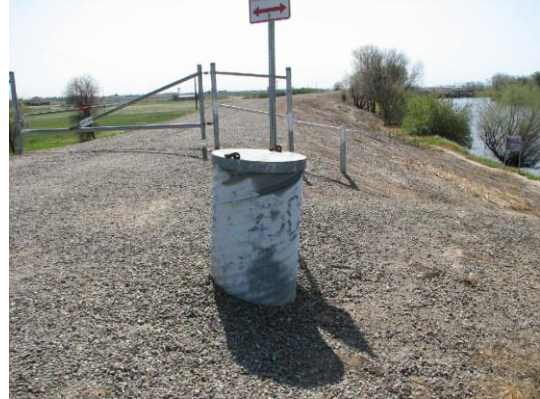
Photo 2 of 2 : UCIP_SP_2016_40683_72332.jpg

CMP riser located on waterward shoulder.

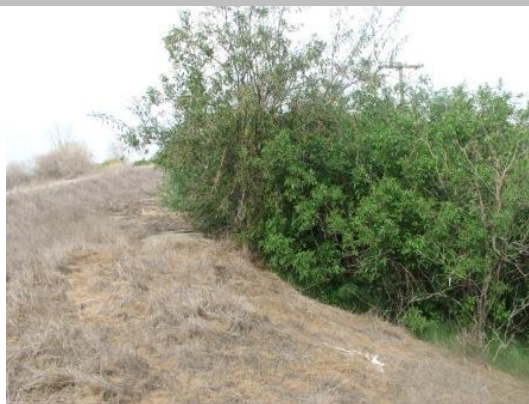
Photo 1 of 1 : SP_2016_RD0017_304_25_20160404_00013.jpg

Elderberry blocking view of landside slope and toe.

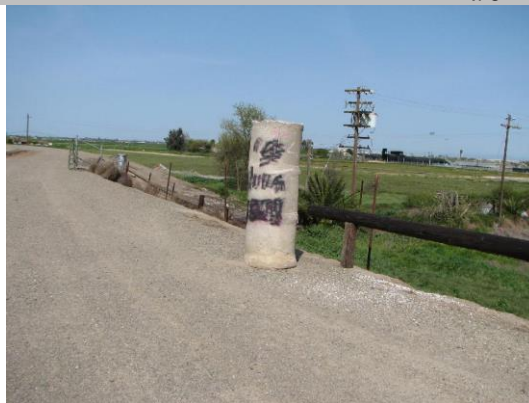
Photo 1 of 2 : UCIP_SP_2016_40686_72353.jpg

Standpipe located on levee crown.

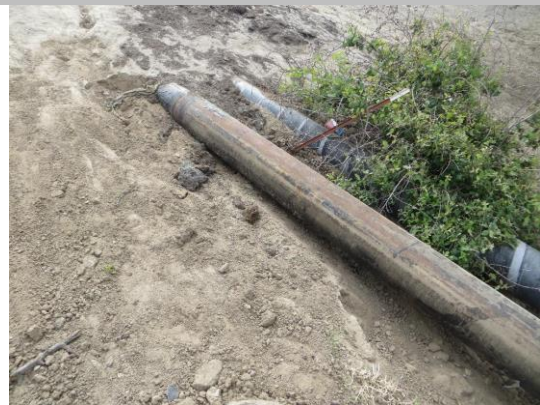
Photo 1 of 2 : UCIP_SP_2016_46008_74471.jpg

(2015) View of waterward side--only 1 pipe section was replaced (1 of 2 and not 2 of 2)

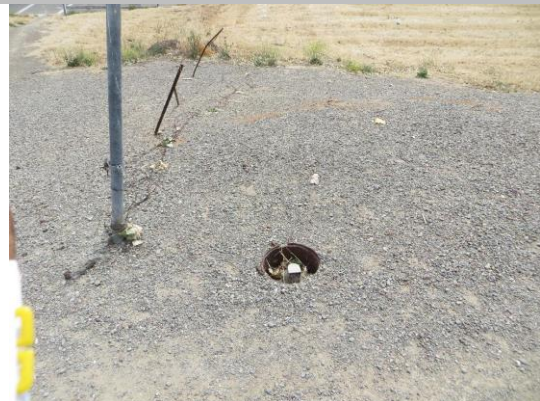
Photo 1 of 2 : UCIP_SP_2016_45464_74125.jpg

Vent in steel riser on LS shoulder.

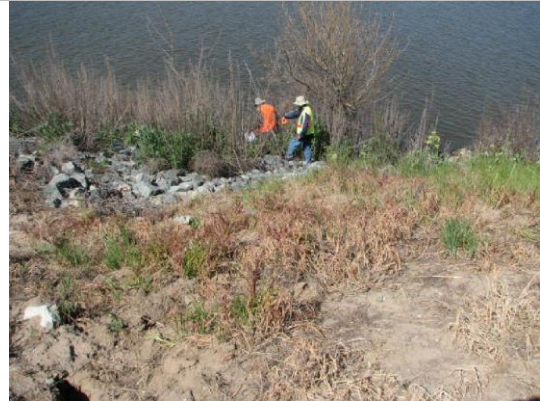
Photo 2 of 2 : UCIP_SP_2016_40706_72511.jpg

View of waterward toe--rip rap along pipe alignment.

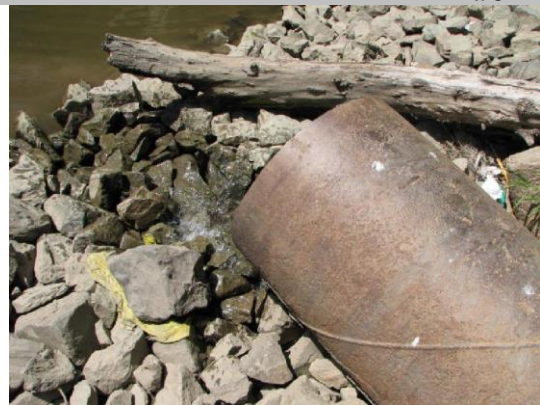
Photo 1 of 2 : UCIP_SP_2016_45466_72523.jpg

Pipe was running during field inspection.

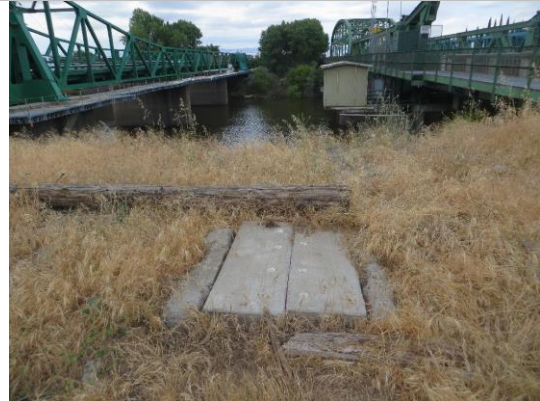
Photo 2 of 2 : UCIP_SP_2016_45466_74131.jpg

Concrete manhole on WS shoulder.

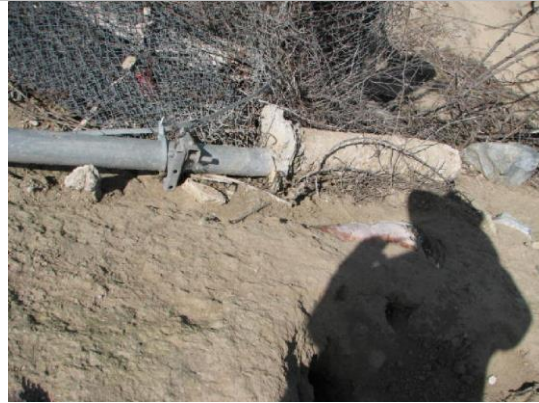
Photo 2 of 2 : UCIP_SP_2016_40712_72528.jpg

Pipe section exposed on landward side.

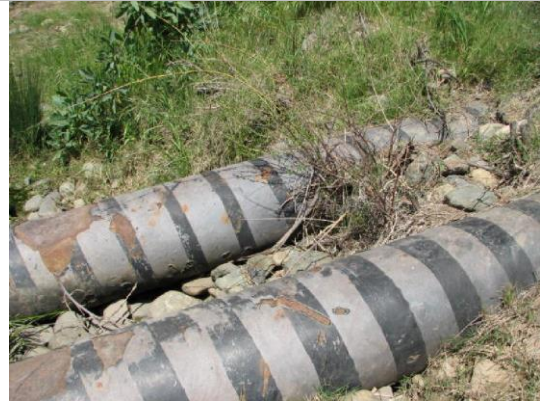
Photo 2 of 2 : UCIP_SP_2016_40713_72533.jpg

Pipes visible on waterward side.

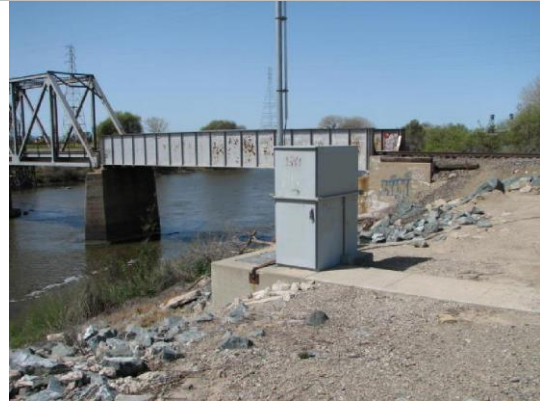
Photo 2 of 2 : UCIP_SP_2016_40714_72539.jpg

Control box and distribution box located on waterward shoulder.

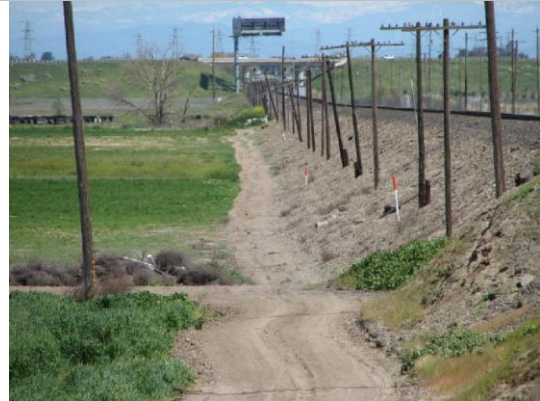
Photo 2 of 2 : UCIP_SP_2016_45995_72525.jpg

Markers visible along landward side.
